Analysis of Converter Transformer Failures and Application of Periodic On-line Partial Discharge Measurements

W. McDermid D.H. Grant A. Glodjo J.C. Bromley
Manitoba Hydro
P.O. Box 815, Winnipeg MB Canada R3C 2P4
wmmcdermid@hydro.mb.ca

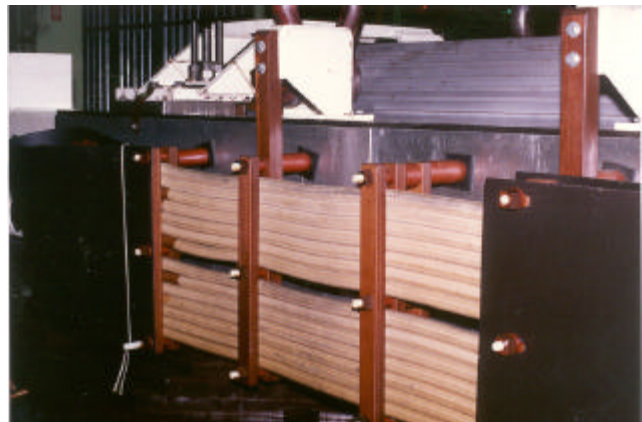
In the case of the transformer from the rectifier, the cause of the gassing was more complex. The tap leads are arranged in parallel with the top and bottom yokes of the core as is shown in Figure 1 and are connected at the tap changer so as to place in series the individual tap windings. As all the tap leads at the top yoke have one polarity, while those at the bottom yoke have the opposite polarity, there is considerable net stray flux when the transformer is operating on an extreme tap. This resulted in eddy current heating of the adjacent core laminations (Figure 2), and possibly also eddy current heating of the adjacent winding conductors. As the transformers at the rectifier tend to operate closer to an extreme tap, continuous aluminum shields were placed on the top and bottom yokes of the core on the side closer to the tap leads. These shields were connected between top and bottom at each end of the core so as to provide a continuous shield with the intention of reducing the stray flux heating of the core. At first the continuous shield was provided only for the one gassing transformer from the rectifier. After about 14 years of operation, two additional transformers, having evidence of gassing, were returned from the rectifier to the factory and the continuous shield was installed.

Fig. 1 Location of tap leads at top yoke of core

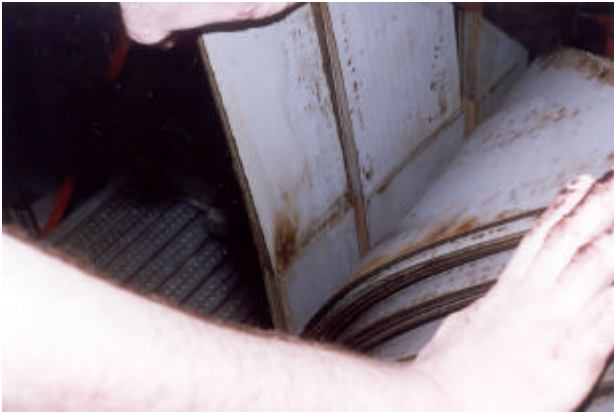
Fig. 2 Evidence of overheating of outer laminations of vertical limb adjacent to top yoke of core after approximately 14 years of operation

During internal inspections in 1988, after about ten years of service, it was common to find the rubber oil seal dislodged between the discharge from the oil circulation pumps and the bottom core clamping structure from which the oil was forced through the coil assembly. An improved oil seal was installed. It was also observed on these occasions that the laminations of the top yoke of the core were relatively loose and in some cases shifted laminations were found. It was common to find evidence of overheating at the mitre joints at the top yoke of the core.

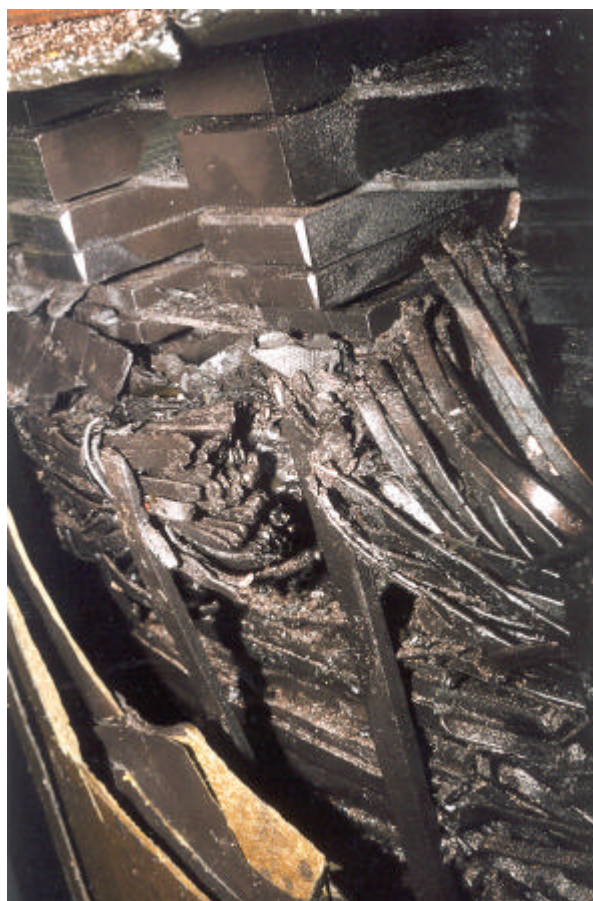
showed high exciting current on Leg 2 and the ratio for this leg indicated that there were shorted turns in the valve winding. Resistance measurements indicated that the Leg 2 valve winding was open circuited. Upon removal of the outer pressboard, shorted turns and open circuit strands could be seen at the top of the Leg 2 valve winding, as is shown in Figure 3.

Fig. 3 November 1999 failure showing shorted turns and open strands involving Leg 2 of valve winding adjacent to top static ring

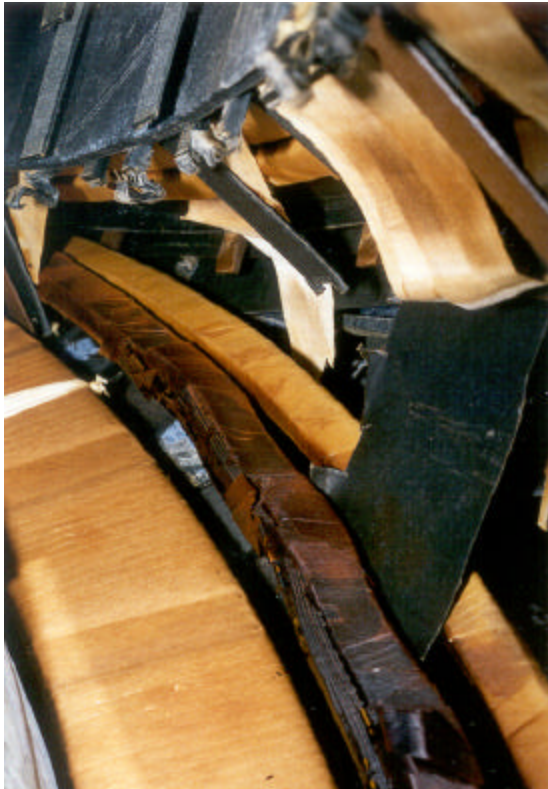
The star connected valve winding has two parallel bundles of CTC. The unique aspect of this failure is that the paper wrap on one bundle in the top disc was virtually incinerated on all three legs. An example is shown in Figure 4. In these locations

Fig. 4 February 2000 failure showing incinerated paper wrap on 1 of 2 CTC bundles of Leg 3 valve winding at top adjacent to static ring

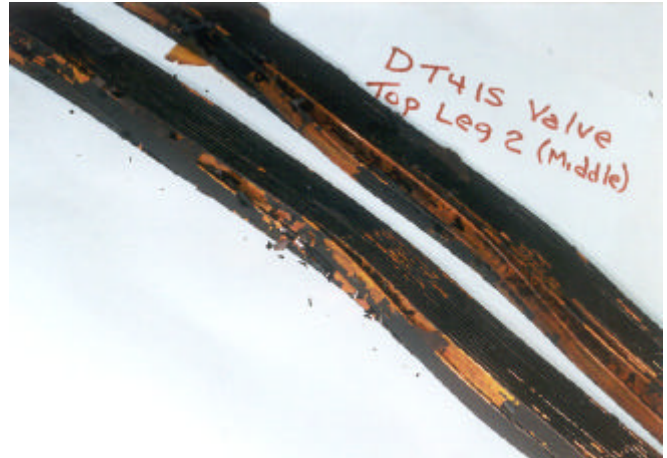
the enamel on the strands had been destroyed. Figure 5 shows typical thermal damage to the enamel.

Fig. 5 February 2000 failure showing thermally degraded enamel on strands of Leg 2 valve winding at top of coil near static ring

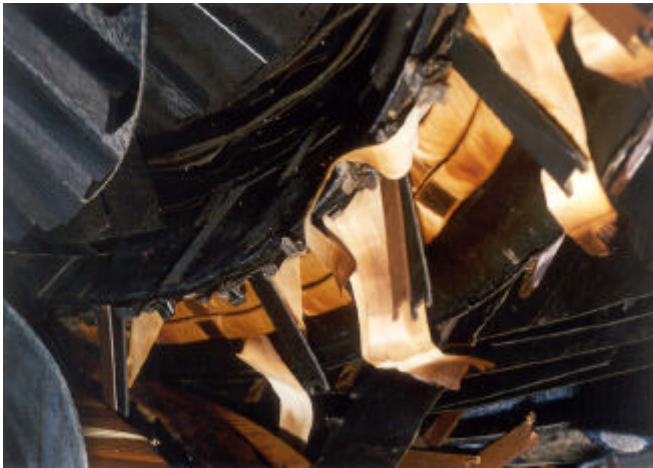
It was also observed in the case of Leg 2 that the bundles of CTC in the valve winding had been bent into somewhat of a clover leaf shape as is shown in Figure 6.

Fig. 6 February 2000 failure showing distorted CTC bundles of valve winding at top of Leg 2

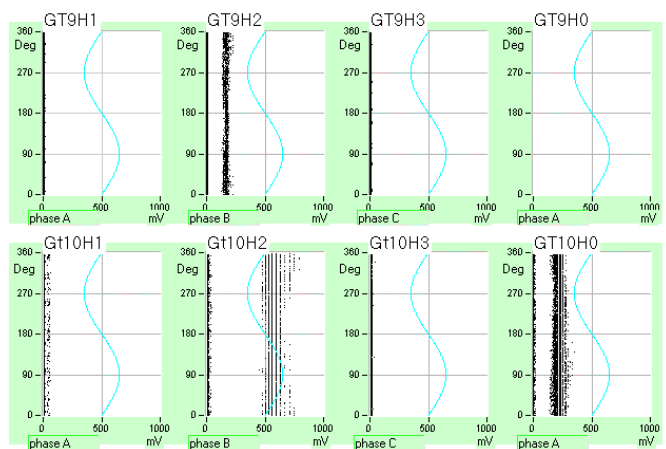
Fig. 8 On-line PD measurement from 138 kV bushings and neutral bushing of generator step-up transformers GT9 and GT10

It will be noted that a very high level of discharge activity was measured over the complete 360° of the 60 Hz voltage from the capacitance tap of the GT10 H2 bushing. Lesser activity was measured from the GT10 H0 (neutral) bushing which has

a RF CT attached to the ground connection. In addition, some response was also observed from the GT9 H2 bushing capacitance tap. These two transformers are connected in parallel by a short length of bus on the 138 kV side.

Upon investigation, it was found that the small capacitance tap bushing was loose on the 138 kV bushing of GT10 H2 and that there was evidence of oil leakage at this location. This 138 kV bushing has now been replaced. While the PD may have been as a result of a poor contact between the tap bushing and the condenser core, it is also possible that sufficient oil had been lost so as to expose the paper insulation of the bushing. A previous failure of a 138 kV bushing of a different type on one of the generator step-up transformers at the same station ultimately resulted in the failure of the transformer, a major oil spill and fire damage.
