Analysis of Converter Transformer Failures and Application of Periodic On-line Partial Discharge Measurements

W. McDermid D.H. Grant A. Glodjo J.C. Bromley
Manitoba Hydro
P.O. Box 815, Winnipeg MB Canada R3C 2P4
wmmcdermid@hydro.mb.ca

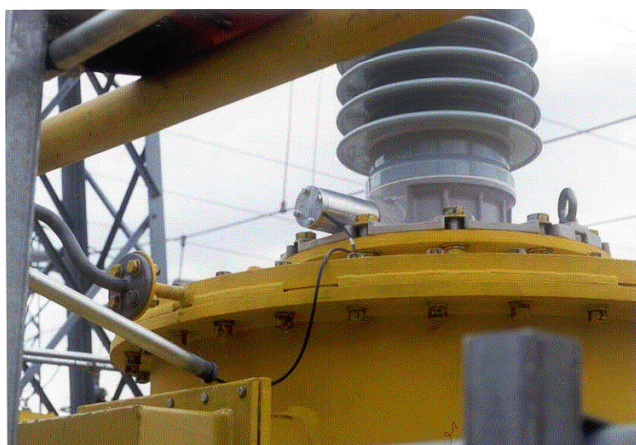
The PD sensors consist of ferrite core RF current transformers that are installed on the ground connection to the capacitance tap of the bushings as is shown in Figure 7. The partial discharge analyzer is based on two Yokogawa DL1540L oscilloscopes that can monitor 8 channels simultaneously. As is discussed in [4], the noise cancellation methods used by this analyzer include:

Fig. 7 PD sensor at bushing capacitance tap
